Manhole Inspection Summary

Manhole # S15AA2003MH

Location Address: **2109 CARTERDALE RD**

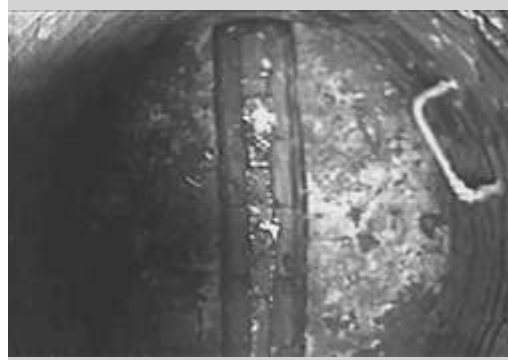
Top View

Corbel infiltration. Bench debris.

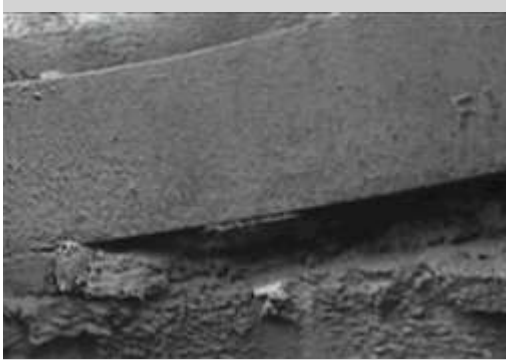
Defect

Frame leaks. Adjustment deterioration, loose brick and infiltration.

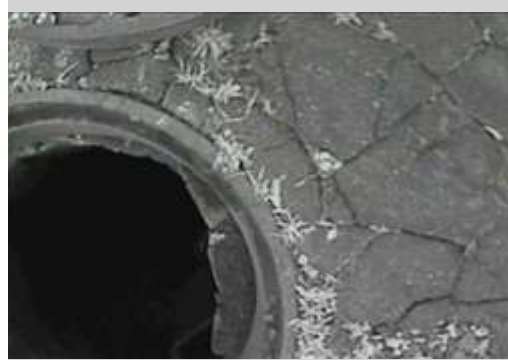
Defect

Frame offset. Adjustment deterioration, loose brick and infiltration. Cracks in pavement.

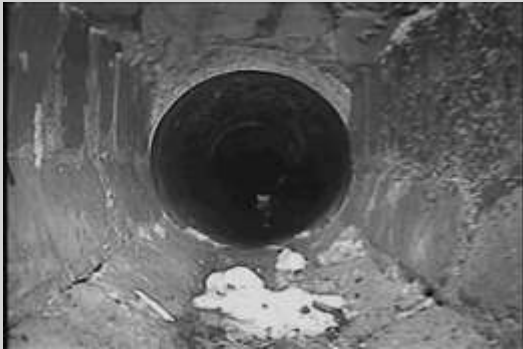
8 in. Circular Gravity Sewer Pipe Out @ 12 O'Clock

Channel deterioration.
